## Information Bulletin #2022-2

**Problem:** Water infiltration into the wind generator.

**Solution:** Visual inspection to identify potential problems.

**Equipment:** All wind generators.

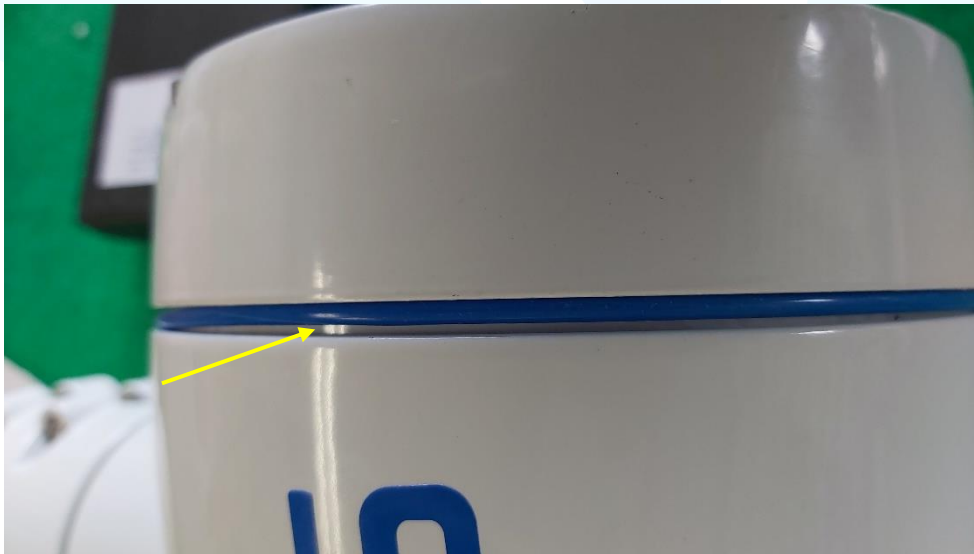
*Photo 1 – Front face not completely closed - example*

- Screws from the Front Face were not completely screwed.
- O-ring is not in place.
- No O-ring.
- The stator was not inserted correctly.

- Is there any visible damage to the O-ring?
- Is the O-ring properly fitted?
- Were any gaps noticed between the front face and the body of the wind generator?
- Are the three front-face screws securely tightened?

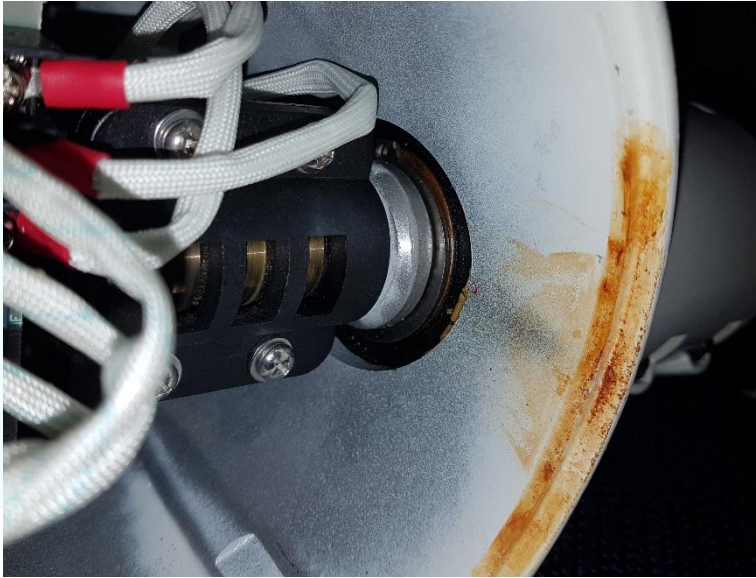
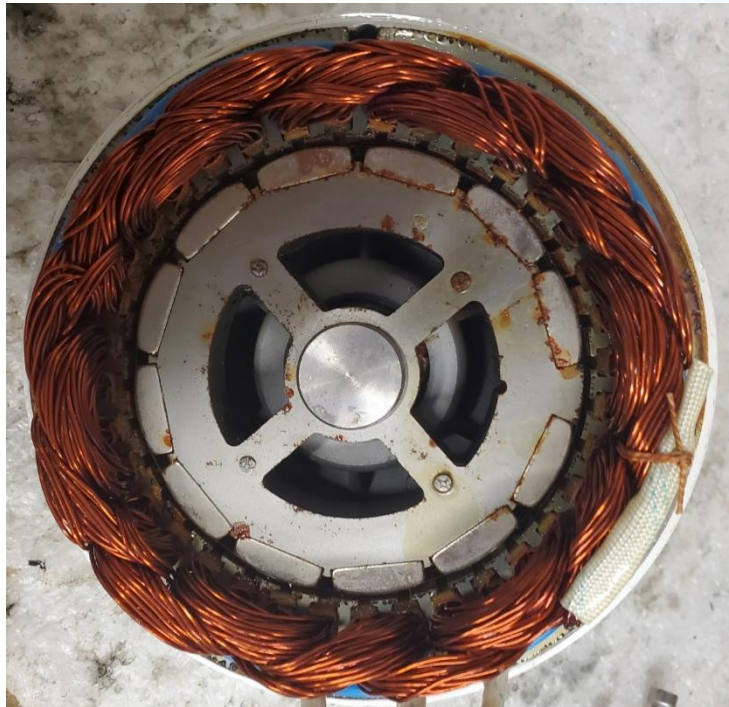
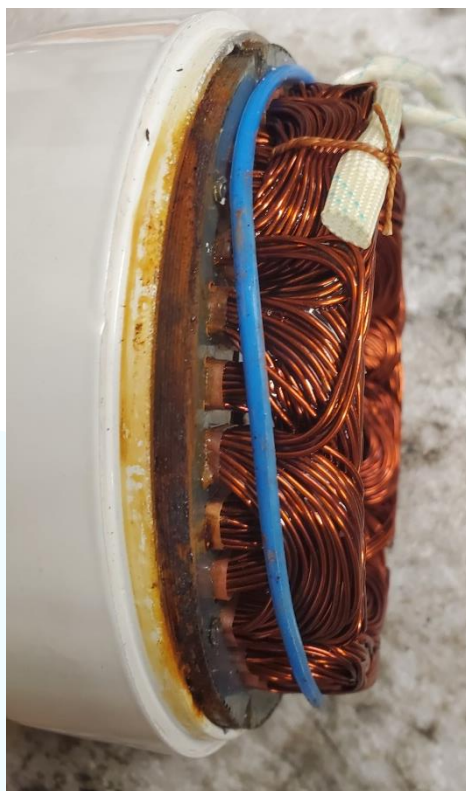
- Corroded yaw bearings: The wind generator does not rotate according to the wind direction.
- Corroded rotor and stator.
- The energy production was also affected.
